20th European Conference on Fracture (ECF20)

Fatigue failure of a flash butt welded rail

Abstract

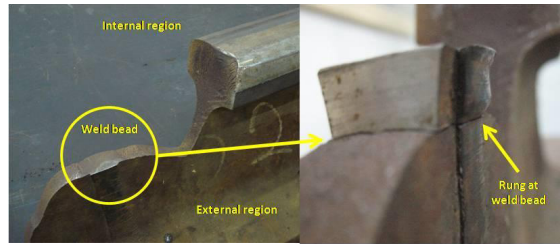
Figure 1 presents the inferior part of the fracture surface of the rail, which was used in the macrofractographic analysis. It is possible to observe the fracture aspects at the head and at the web of rail. The rail web presents a region that reflects more intensely the light (flat and brightening). Figure 1 also shows that this flat region is localized at the internal side of the railroad, where train wheels exert higher effort over structure.

It is important to note that crack nucleation areas are localized at stress concentration regions: welded joint, sharp edges and grinding striations associated to the burr presences due to the welding procedure. These evidences, associated with a cyclic loading, which occurs in a normal operation routine of a railroad, leading to a final diagnosis of fatigue failure.

Fig. 1. Rail fracture surface, highlighting a rung at welded bead.

Considering the flash butt welding procedure and its consequences on the rail welded joint (extremity of rails plastification, burr generation, grinding striations and other several stress concentrators), coupled to the work life of railroad under continuous fatigue cycles loading, some recommendations are suggested. Before welding procedures realization, rail extremities should be well cleaned, as the welding plant line. Undesirable dirt could contaminate the welding line causing the presence of impurities at metal welded structure; after welding procedures, rails should not be highly moved while they are in high temperature. Rails moving in high temperature may cause permanent strain at welded joint, creating another structural discontinuity; the dimensional and finishing control of welding burr must be urgently modified. More stringent criteria for burr removal and superficial finishing must be adopted aiming to decrease stress concentration points in welded joint.

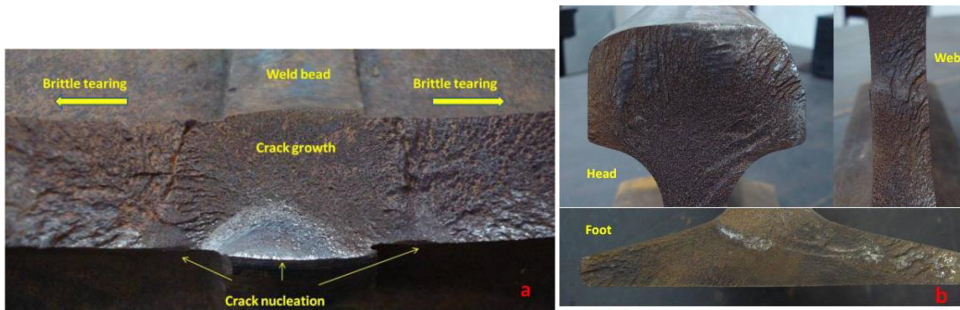
Figure 2 (a) presents a detail in the welded region. It is possible to observe three flat surfaces that reflect light more intensely. One of these flat surfaces, the biggest and central, highlights, because it has a curvature radius of almost one third of web rail thickness. This area characterizes the nucleation and stable crack growth. Radial marks are observed at right and left side of the welded joint. This is an evidence of crack instable growth (brittle fracture) in a long extension.

Figure 2 (b) presents pictures of rail parts (head, web and foot). In these areas is also possible to see radial marks, indicating that these parts were fractured by brittle mechanisms. It is supposed that fatigue crack grew until get a specific curvature radius (one third of rail web) considered the critical size and promoting a stress intensity factor correspondent to the material fracture toughness, causing a catastrophic failure at welded joint.

Fig. 2. (a) Detail of crack nucleation and stable growth regions (intense light reflection – flat surface). Brittle tearing areas (radial marks); (b) Head, web and foot presenting brittle fracture surfaces.

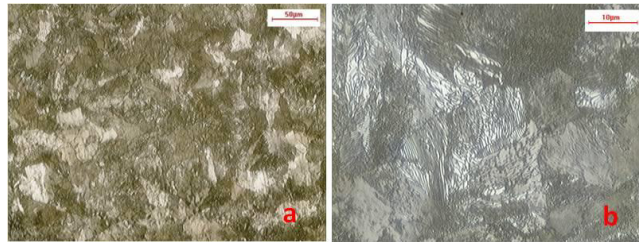
Figure 4 presents micrographs of BM regions etched with Nital 2%. As expected, the steel structure in base metal is constituted of pearlite. The coarser pearlite, the higher light reflection and the whiter constituent is. Fine pearlite (major fraction) has darker colors, because its colonies reflect less light.

Fig. 4. Micrographs of BM; Nital 2%, OM. (a) 400X; (b) 2000X.

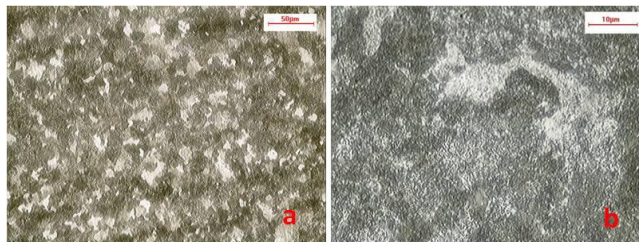
Figure 5 presents micrographs of HAZ regions. These figures show the pearlite fragmentation (Iron carbide diffusion and cementite lamellae partially disintegrated) due to high heat input during welding process in this area.

Fig. 5. Micrographs of HAZ; Nital 2%, OM. (a) 400X; (b) 2000X.

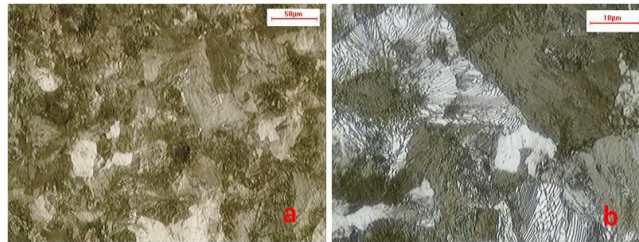
Figure 6 shows micrographs of WB regions. In this area it is possible to observe that colonies of pearlite have higher sizes, indicating higher previous austenite grain sizes. In Figure 7 it is possible to see the central line. In this line, the microstructure is constituted of pearlite and proeutectoid ferrite. Ferrite grains are localized at pearlite colonies boundaries indicating local decarburization.

Fig. 6. Micrographs of WB; Nital 2%, OM. (a) 400X; (b) 2000X.

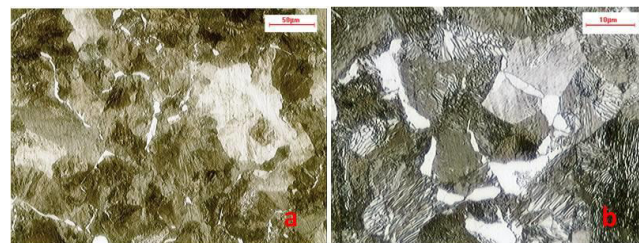
Fig. 7. Micrographs of CL; Nital 2%, OM. (a) 400X; (b) 2000X.

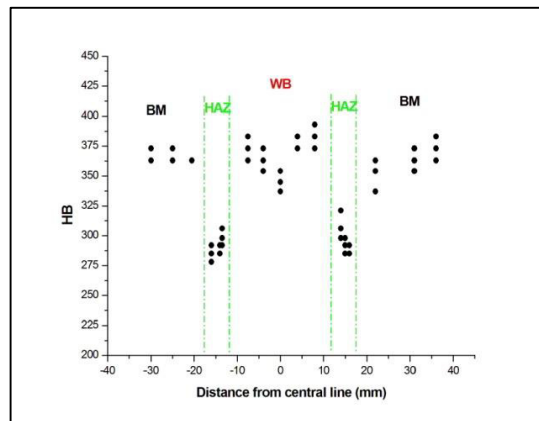
The used sample in the microstructural characterization was submitted to Brinell hardness test ($F=187,5\text{kgf}$, $d=2,5\text{mm}$). Measures were done in BM, HAZ, and WB regions and CL. Figure 8 presents Brinell hardness profile measured in the failure welded joint. As expected, obtained values in BM and WB were similar, because both structures are pearlitic with small differences between colony sizes and interlamellar spacing. In CL, hardness values decrease slightly. This result may be explained due to proeutetoid ferrite presence in this area. In HAZ, hardness values presented a high decrease, justified by pearlite fragmentation verified in this region.

Fig. 8. Brinell hardness data. BM = base metal; HAZ = heat affected zone; WB = weld bead; central line (CL) at reference position 0.

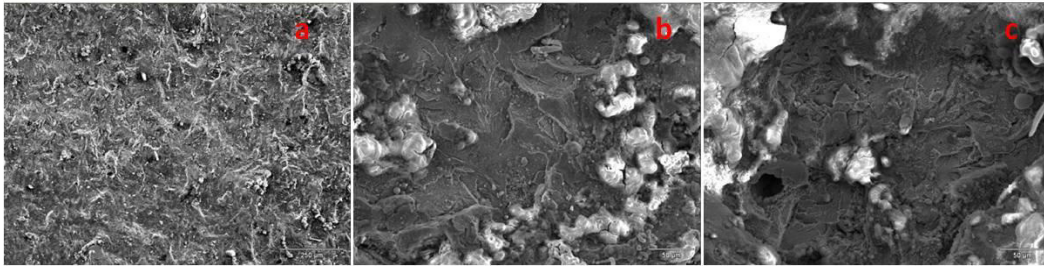
The microfractographic analysis was performed in a scanning electron microscope. In Figure 9(a) it is possible to confirm the phenomenon of fatigue as the main cause of crack nucleation and stable growth. Figure 9 (b) presents the transition area of stable to instable crack growth. Finally, in Figure 9 (c) it is possible to see cleavage facets and river marks, indicating a final brittle fracture caused by a tensile overload.

Fig. 9. (a) Start of fatigue crack spread (100X); (b) transition area (350X); (c) brittle fracture area (350X).

According to the results obtained, it is possible to affirm that the studied failure was caused by two mechanisms. First, a fatigue crack nucleated and grew steadily in the welded bead, specifically in internal parts of the rail web, where severe stress concentrators were observed (coarse burrs, grinding striations, sharp edges). Second, the fatigue crack grew, initially stably, until a critical size. As the material studied is a hipereutetoid microalloyed steel, with high mechanical strength and limited ductility, when it was subjected to specific overload levels, the existing crack grew unstably, until the catastrophic fracture of rail.
