20th European Conference on Fracture (ECF20) Fatigue failure of a welded automotive component

L.B.Godefroid^a*, G.L.Faria^a, L.C.Cândido^a, S.C.Araujo^a

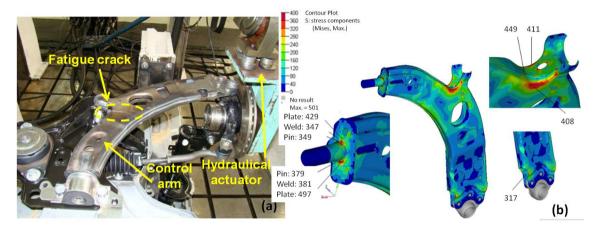
An important and careful quality control test that is applied to automotive components is the fatigue test. In this test, the component is submitted to several loading blocks, and must resist without fail, for a specified number of cycles usually determined by the client. Figure 1(a) shows a control arm being tested in fatigue by a automobile industry. The application of fatigue loads induces a stress distribution, as shown in Figure 1(b). It is possible to see a crack that nucleates and grows in a region of high stress concentration. This work investigates the cause of undesirable appearance of this fatigue crack.

Fig. 1. (a) A control arm being tested by fatigue. (b) Stress analysis in the control arm.

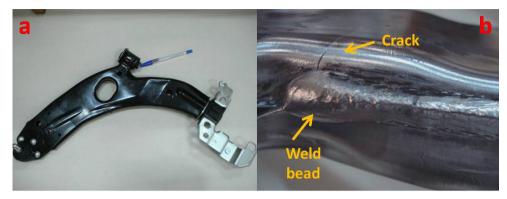
Figure 2 (a) presents a control arm tested in fatigue. Figure 2(b) shows a detail near to the weld bead, where it is possible to see a crack. This crack started at a stress concentration area, exactly at the point where the welding procedure started. The big amount of deposited material in this region indicates that the welding process in this component started with a high heat input.

Fig. 2. (a) A control arm after a fatigue test. (b) Detail of the fatigue cracking at the weld bead.

The beginning of the welding procedure occurs with high material deposition, indicating that it is made with relatively high heat input. The fatigue cracking initiated in this region. This high amount of heat produces a microstructural variation, leading to significant loss of material properties. It would be interesting to change the welding procedure, to greater homogenization and microstructural behavior.

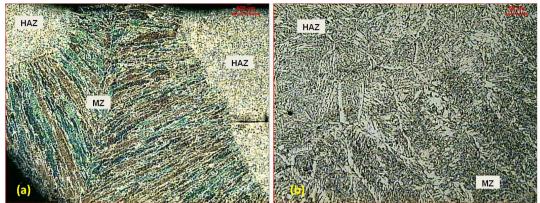
Significant microstructural variation exists in the weld bead, being possible to distinguish the traditional microstructures of base metal (BM), heat affected zone (HAZ) and molten zone (MZ), as shown in Figure 4. The beneficial effects of microalloying elements will be minimized in this region.

Fig. 4. Microstructure of the welded joint. (Nital 2%, OM). (a) 25X; (b) 200X.

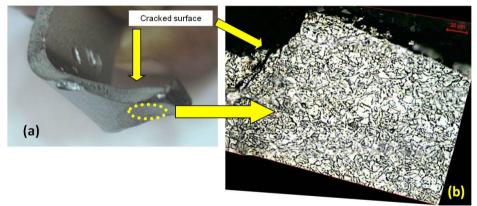
According to observation mentioned on visual analysis, in the region where the fatigue cracking under analysis starts (which corresponds to the beginning of the welding process) it's possible to see the application of a heat input greater than the rest of the welding procedure. Consequently, the microstructural variations in this region are more intense. This fact can be demonstrated in Figure 5, which corresponds to the region immediately below the fatigue cracking. This picture corresponds to a plane perpendicular to the fracture surface. The microstructure observed in this figure is close to the heat affected zone (HAZ).

Fig. 5. Microstructural analysis of the control arm in a region immediately below the fatigue cracking. (a) the analyzed region; (b) corresponding microstructure. (Nital 2%, OM, 500X).
